1850 Centennial Park Drive, Suite 301, Reston VA 20191 | www.gobrick.com | 703-620-0010

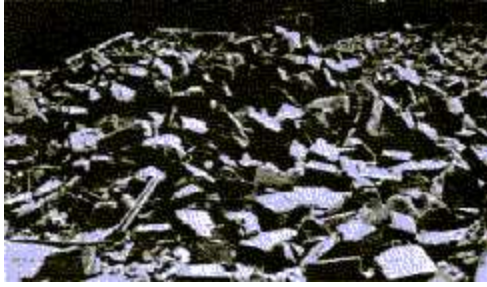
FIG. 1

When existing walls are demolished, hard-burned brick and salmons are hopelessly mixed. It is virtually impossible to distinguish between durable and non-durable units.

One common characteristic of most manufactured building materials is a reasonable degree of uniformity within a particular grade or within a given manufactured lot. Salvaged brick lack this distinction. Hard-burned and soft-burned brick, hopelessly mixed during wrecking operations, effectively create a material stockpile of two widely differing grades of materials (see Figure 1). A sample of the material will contain specimens of each grade. If tested for absorption or compression strength properties, the sample will show widely diversified characteristics. The average absorption or strength will not approximate the true values for either grade, but will lie somewhere between. In effect, it is difficult to determine whether salvaged brick will meet present day material specifications or building code requirements.

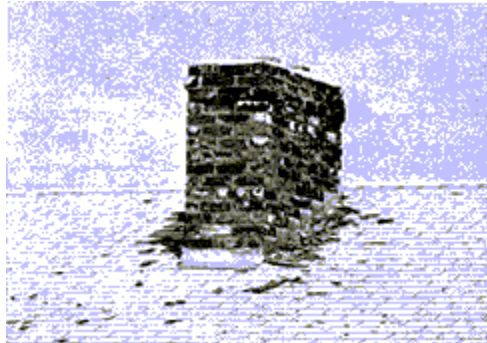
FIG. 2

A chimney of salvaged brick which has spalled considerably within a relatively short time after construction (Knoxville, Tennessee).

Esthetics. Salvaged brick may satisfy the desire for a rugged, colorful masonry surface. Architects often desire the extreme range of colors from dark-red to the whites and grays of units still partially covered with mortar. But most frequently the light pink color of the salmon creates the desired effect. Unfortunately, the pink in salmons results from under-burning which produces units that must not be exposed to weathering. Excessive disintegration due to weathering can soon drastically alter the appearance originally desired (See Figs. 2 - 4).

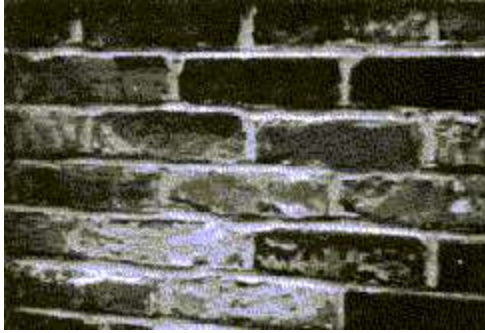
FIG. 3

A close-up of a wall indicating the excessive spalling that is likely to occur where salvaged brick are exposed to weathering.

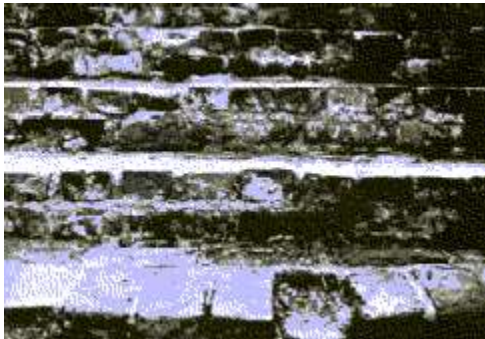
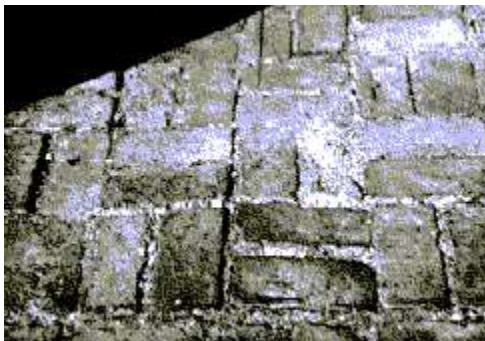
FIG. 4

Because of the greater likelihood that moisture will be present, salvaged brick should not be used for exterior patios, walks, pavements, etc.
